Inspection Report

This inspection performed in accordance with current "Standards of Practice" of National Association of Certified Home Inspectors

**Art Nouveau
220 4th Street
Equinunk, PA 18417**

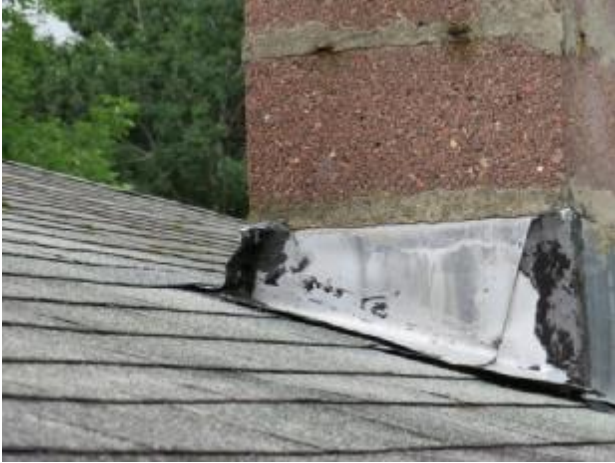
#R1

1. Chimney at back of house has loose flashing and no cricket. Recommend a reputable contractor. (see photo 1).

Loose flashing and no cricket

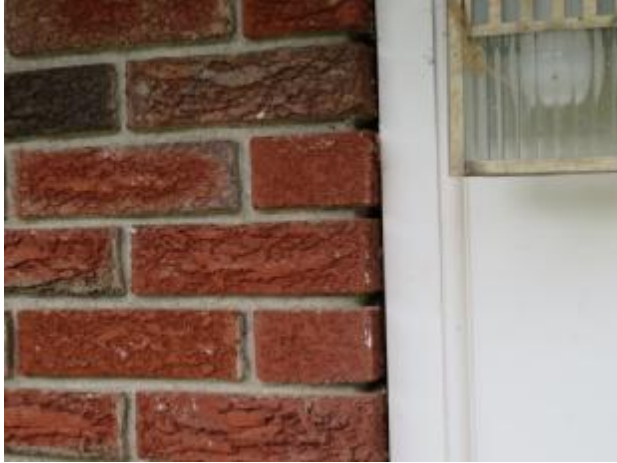
#EX1

1. No caulk around trim on back door. This will allow for water and pest infestation. Recommend caulking the perimeter of trim. (see photo 1).

No caulking

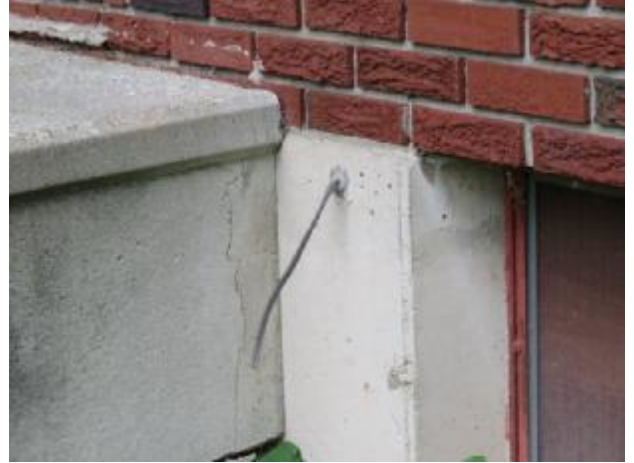
#EX2

2. Incomplete circuit. This wire is installed for an electric receptacle not hooked up yet. Recommend a reputable licensed electrical contractor. (see photo 2).

Incomplete electrical circuit

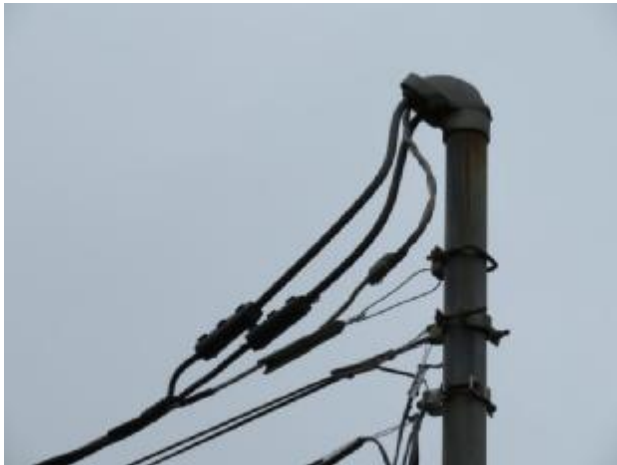
#EX3

3. **SAFETY HAZARD.** Incorrect drip loop on overhead service. Recommend a reputable licensed electrical contractor. (see photo 3).

Inadequate drip loop

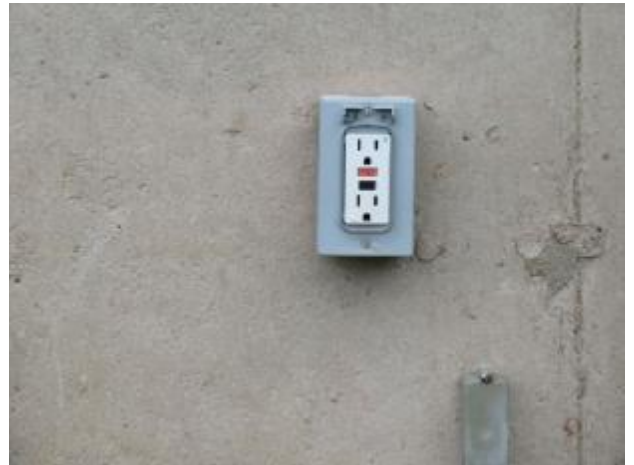
#EX4

4. Broken weather resistant cover on GFCI by basement entrance. Recommend replace the cover. (see photo 4).

Broken cover

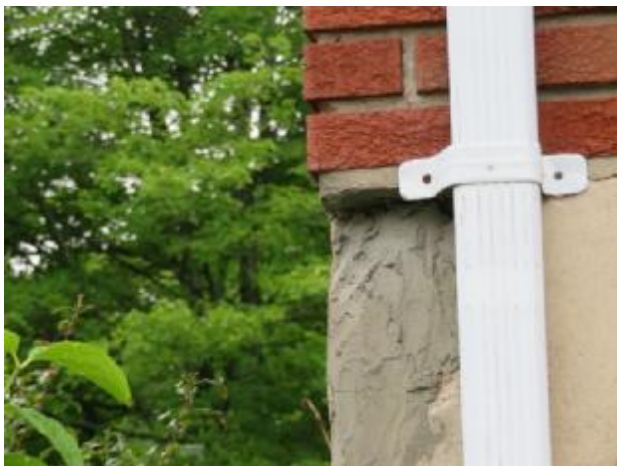
#EX5

5. Incomplete repair on broken corner of foundation. (see photo 5).

Broken foundation corner

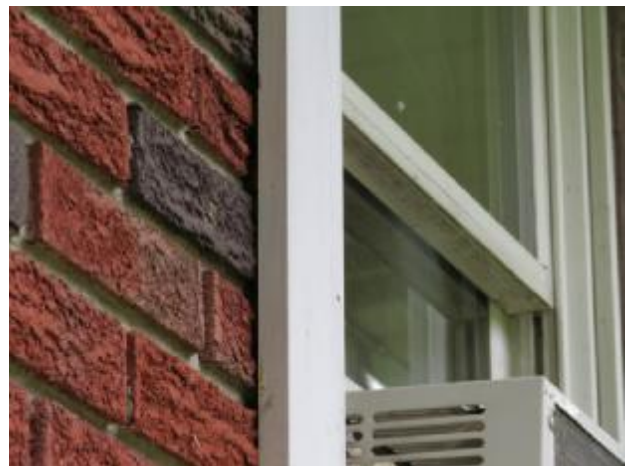
#EX6

6. No caulk on window trim on left side of house. This will allow for water and insect infestation. Recommend caulking the perimeter of trim. (see photo 6).

Missing caulk

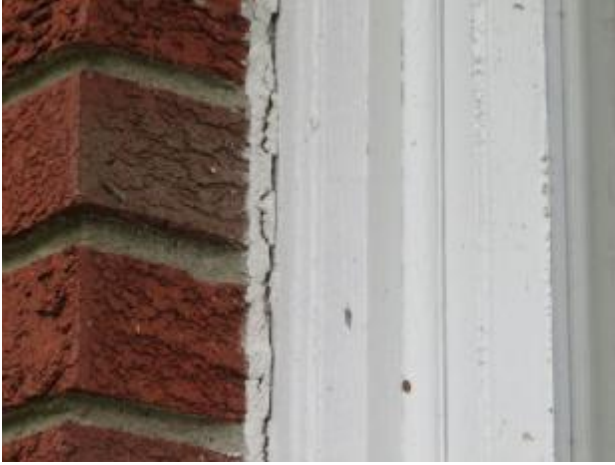
#EX7

7. Failing caulk on front bow window. This will allow for water and insect infestation. Recommend applying new caulk. (see photo 7).

Failing caulk

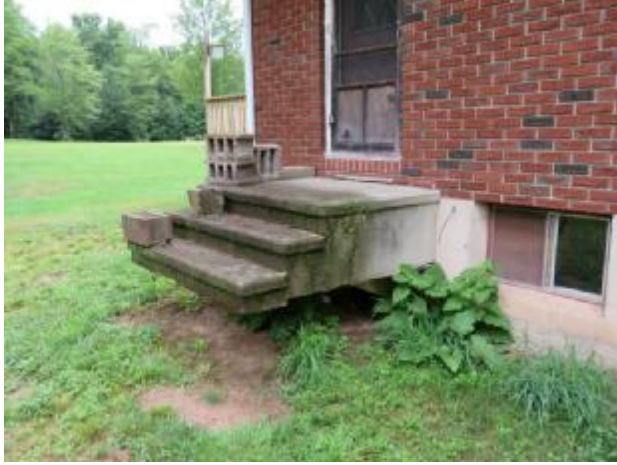
#GD1

1. **SAFETY HAZARD.** Precast concrete steps and porch are too far above the ground with no railings. Recommend a reputable contractor. (see photo 1).

Incorrect stairs with no railing

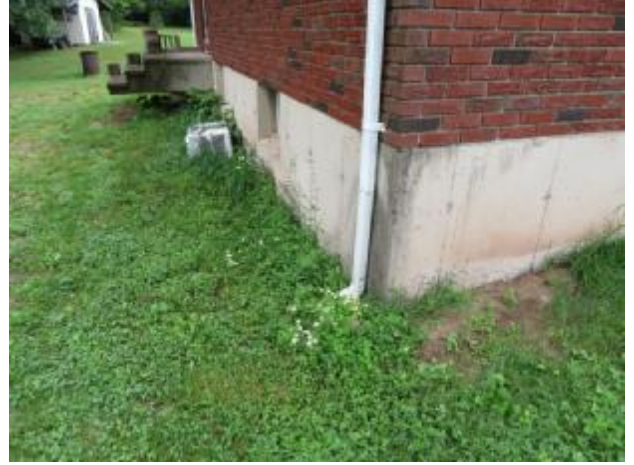
#GD2

2. Down spout has no extension. Recommend installing an extension at least 6 feet long. (see photo 2).

No down spout extension

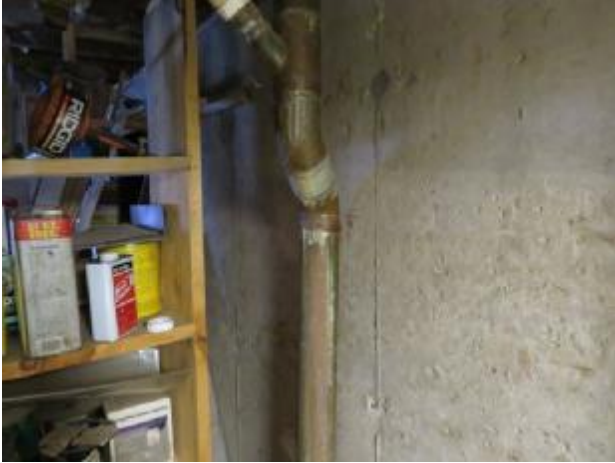
#P1

1. Incorrect repair on copper waste pipe. This is a 3" pipe that is the main waste water exit from the house and should be increased to 4" diameter. (see photo 1).

Incorrect repair on waste pipe

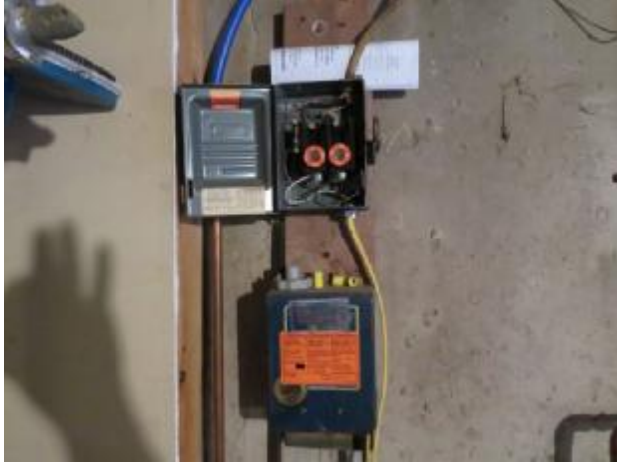
#EL1

1. Water pump has a fuse type power cut off. Recommend a reputable licensed electrical contractor. (see photo 1).
2. **SAFETY HAZARD.** Electric receptacle by main electric panel is not GFCI protected and the receptacle box has no cover and is incorrect type for the application. Recommend a reputable licensed electrical contractor. (see photo 2).
3. **SAFETY HAZARD.** Sub panel has no main breaker and the panel box is mounted directly to the foundation wall with no plywood backer board. Recommend a reputable licensed electrical contractor. (see photo 3).

Fuse box

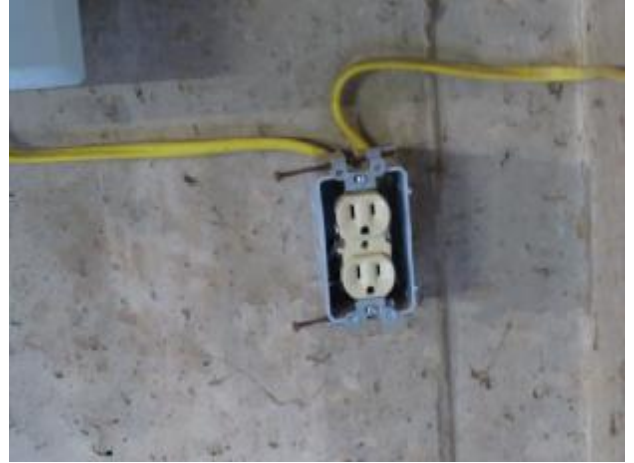
#EL2

SAFETY HAZARD. Electric receptacle by main electric panel is not GFCI protected and the receptacle box has no cover and is incorrect type for the application. Recommend a reputable licensed electrical contractor.

Not GFCI

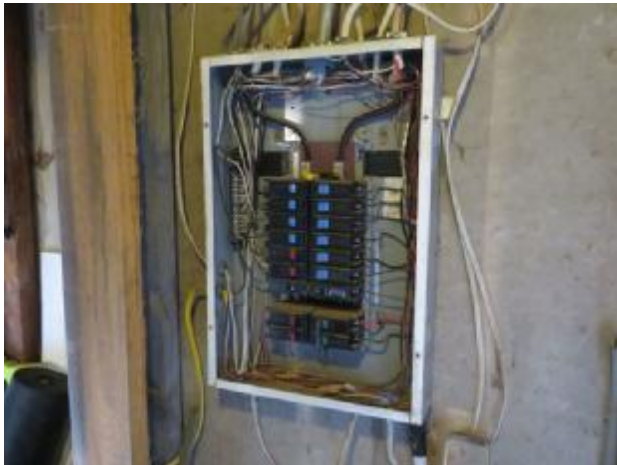
#EL3

SAFETY HAZARD. Sub panel has no main breaker and the panel box is mounted directly to the foundation wall with no plywood backer board. Recommend a reputable licensed electrical contractor.

No main breaker

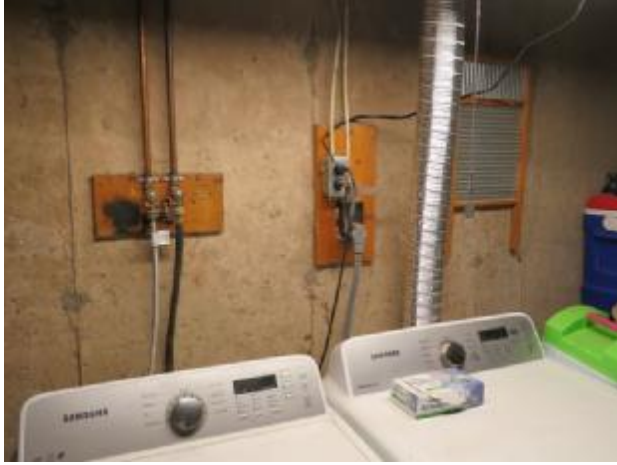
#K1

1. **SAFETY HAZARD.** Electric outlet by washer machine not GFCI protected. Recommend a reputable licensed electrical contractor. (see photo 1).
2. **SAFETY HAZARD.** Electric outlet by kitchen sink is not GFCI protected. Recommend a reputable licensed electrical contractor. (see photo 2).

No GFCI

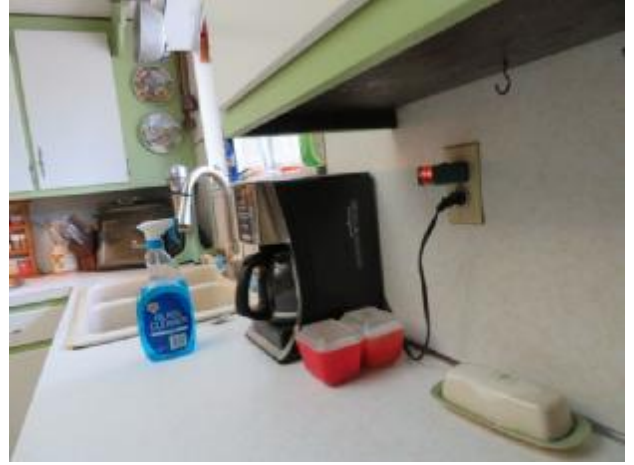
#K2

SAFETY HAZARD. Electric outlet by kitchen sink is not GFCI protected. Recommend a reputable licensed electrical contractor.

Not GFCI

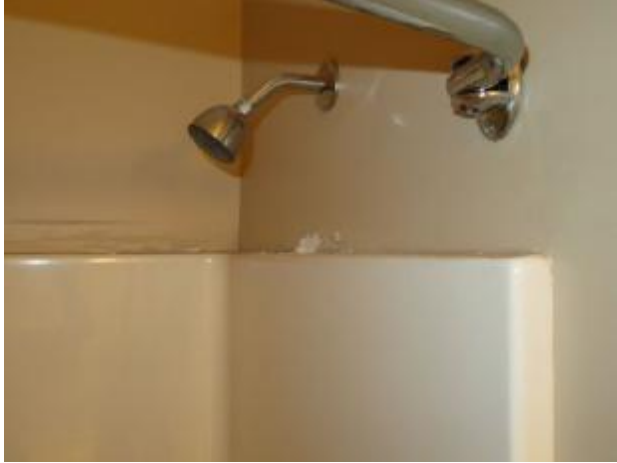
#B1

14
 1. Drywall on top of the tub surround in the hall full bath is deteriorating from moisture. Recommend repair drywall and paint for moisture resistance. (see photo 1).

Water damage

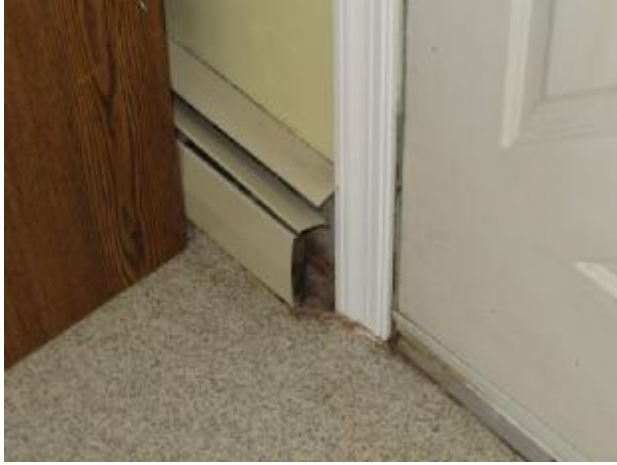
#IR1

SAFETY HAZARD. End cap on base board heat by left side entrance is missing an end cover. Sharp edges could cause injury. Recommend installing end cover.

Missing end cover

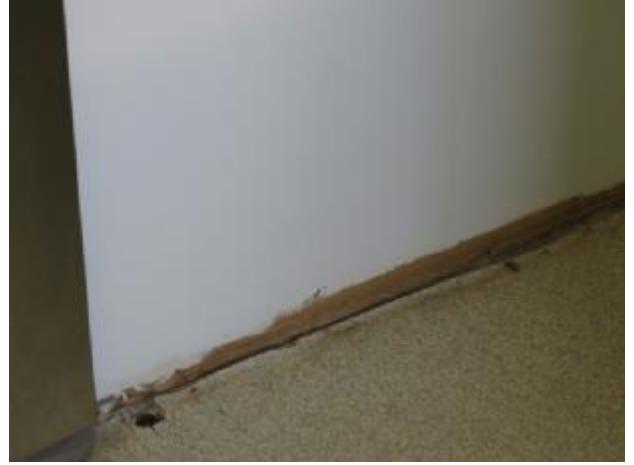
#IR2

Base trim in kitchen hallway is missing. Recommend installing trim.

Missing base trim

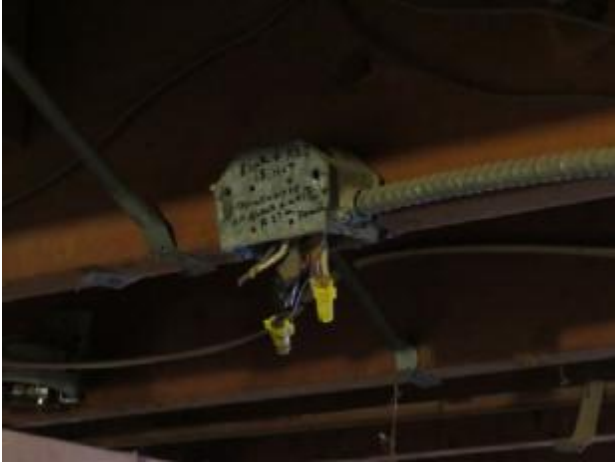
#F1

Electric junction box on basement ceiling has no cover. Recommend installing.

Uncovered junction box.
